Engine damage: Failure caused by cylinder-head gasket? Actual causes and remedial measures

Cylinder-Head Gaskets

Engine failure caused by cylinder-head gasket?

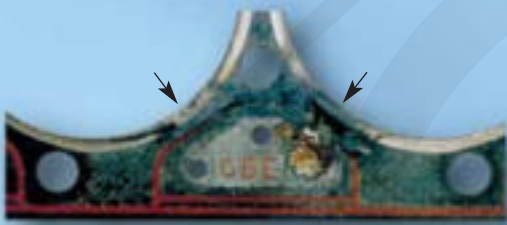
1. Failure of the cylinder-head gasket on commercial vehicles due to gas blow-by

Between cylinders two and three (exhaust area) there is extreme gas over blow. The soft material of the gasket has been destroyed in the area of the water holes.

The cylinder-head gasket was not compressed sufficiently because the bolts were not tightened in compliance with the method specified by the manufacturer. This caused gas blow-by into the cooling water, resulting in increased coolant pressure and loss of coolant as well as the destruction of the cylinder-head gasket.

- Use only new cylinder head bolts to ensure quality and safety.
- Tighten cylinder-head bolts with the tightening torque as specified by the manufacturer.

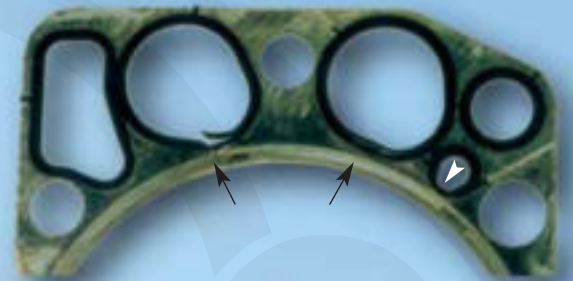
The elastomer sealing element has separated from the gasket carrier at the tappet opening, as well as at the water opening (small arrow). The result is significant loss of water.

An uneven cylinder head surface caused gas blow-by (large arrows). The elastomer sealing elements were pressed away from the carrier plate by the strong gas pressure. The destructive process was accelerated by the constant full-load operation of the engine.

- Carefully check the flatness of the component sealing surfaces before installation. If necessary, resurface.

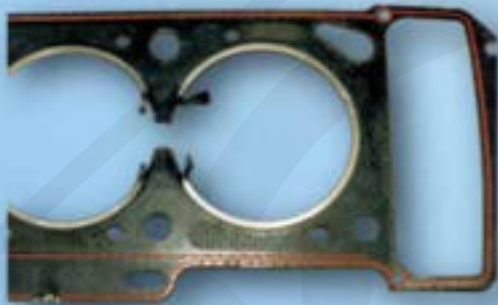
2. Failure of the cylinder-head gasket on passenger cars due to gas blow-by

Sealing web between combustion chambers one and two burnt through.

The gasket was not compressed sufficiently in the destroyed section because the specified bolt tightening torque was not observed or the old cylinder-head bolts were used, resulting in gas blow-by. Overheating then destroyed the sealing web.

- Follow the specified installation instructions closely.

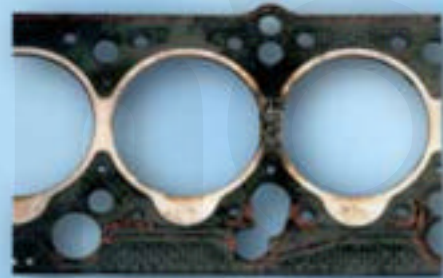
Combustion chamber eyelet and soft material between cylinders three and four scorched. The start of dark discoloration between cylinders three and four.

Uncontrolled combustion process lead to overheating and ultimately the destruction of the sealing material.

- After installation, check injection adjustment.
- Check injection valve carefully and test for leakage.

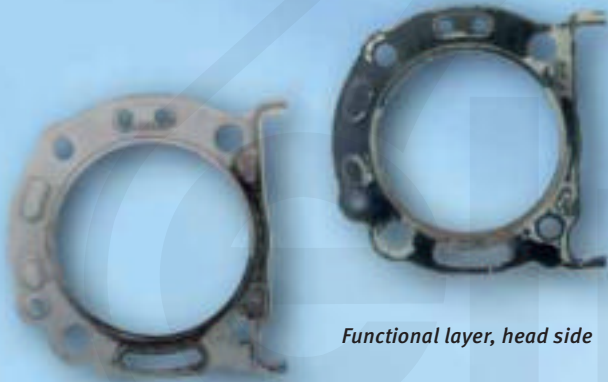
3. Failure caused by gas blow-by on 2-layer metal gasket

The metal stopper layer and the functional layer show significant black discoloration near the cooling duct. Gas has leaked between the stopper layer and the functional layer.

The bolt tightening torque was too low, generating insufficient sealing compression.

- During installation, ensure that the specified bolt tightening torque is applied.

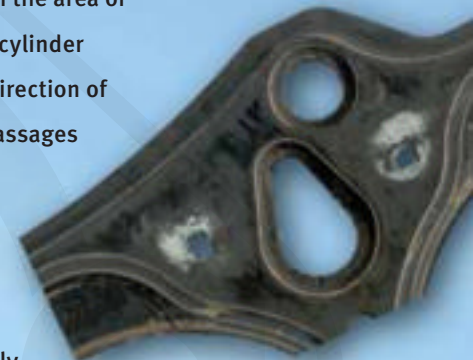
4. Failure due to pressure build-up in the cooling system as a result of gas blow-by

On the multi-layer metal cylinder-head gasket, clear linear impressions can be seen in the area of the water ducts. These come from the cylinder head sealing surfaces and run in the direction of the combustion chamber. The water passages have an obvious light coloration.

The surface structure of the cylinder head was machined either insufficiently or not at all, resulting in the blow-by of combustion gases into the cooling circuit and overheating (pressure build-up).

- Check the condition of the sealing surfaces very closely before installation and ensure that the cylinder head is flat (very fine structure, permissible surface roughness values for the cylinder head machining $R_z 11 \mu\text{m}/R_{\text{max}} 15 \mu\text{m}$).

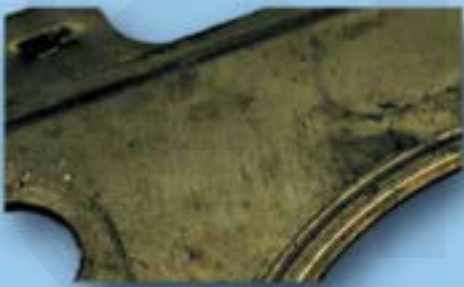
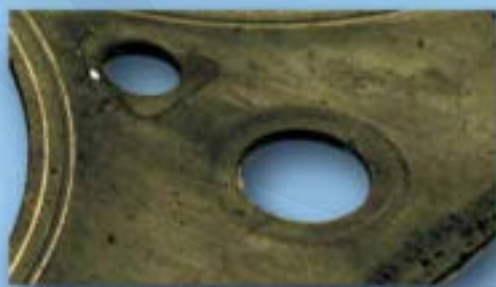
5. Failure of the cylinder-head gasket due to pressure build-up in the cooling system as a result of gas blow-by

Clear linear impressions visible on the multi-layer metal-elastomer cylinder-head gasket. These impressions were made by the cylinder-head sealing surfaces and run in the direction of the combustion chamber.

The surface structure of the cylinder head was machined either too coarsely or not at all. This caused combustion gas blow-by into the cooling circuit and overheating (pressure build-up).

- Check the condition of the sealing surfaces very closely before installation and ensure that the cylinder head is flat (very fine structure, permissible surface roughness values for the cylinder head machining $R_z 11 \mu\text{m}/R_{\text{max}} 15 \mu\text{m}$).

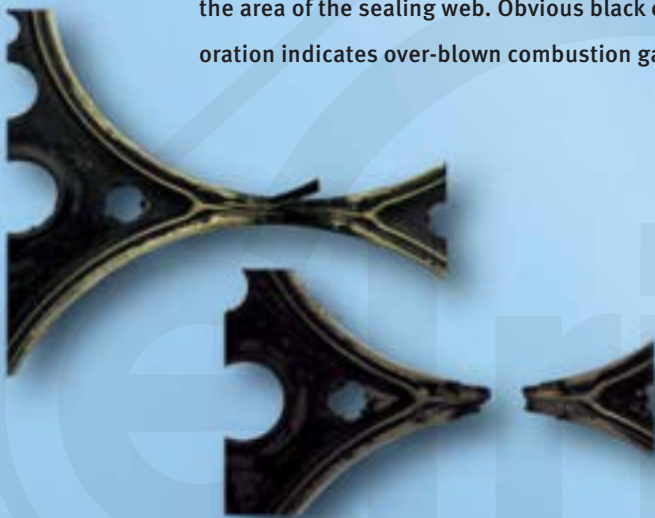
1. Cause of failure – overheating on 2-layer metal gaskets

The metallic functional layer into which the combustion chamber seal is integrated is broken in the area of the sealing web. Obvious black discoloration indicates over-blown combustion gas.

Part distortion resulted in over-blown combustion gases, which in turn overheated the metal layers and led to their destruction.

- Check parts carefully for distortion and surface condition before installation.

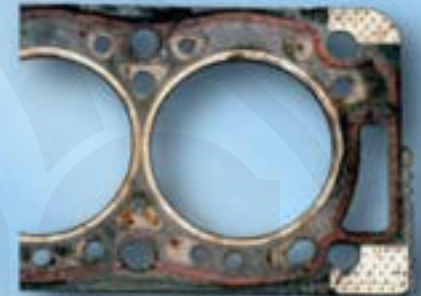
2. Cause of failure – overheating of the metal/soft-material cylinder-head gasket

The exposed soft materials on the gasket are heavily swollen at the water passages.

After installation of the engine, the cooling system was not vented sufficiently. The engine overheated because of excessive coolant temperature. Vaporization led to the swelling of the soft material of the gasket in the area of the water duct, thus separating the soft material of the gasket from the metal carrier.

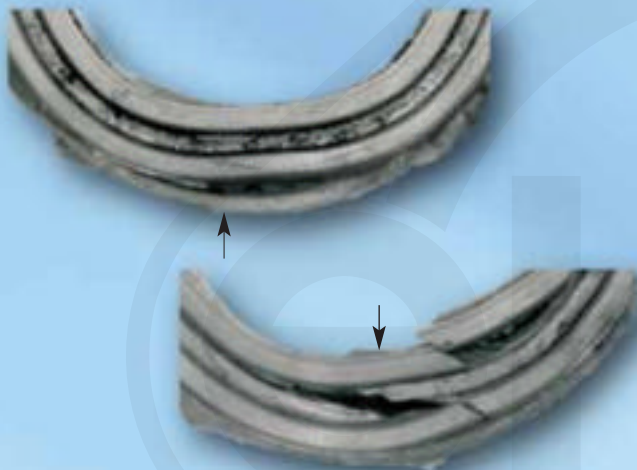
1. Cause of failure – oil leakage, sealing element destroyed during installation of the cylinder head (truck)

The elastomer sealing elements have been pressed away from the carrier plate and cut/torn.

The cylinder head had to be lowered several times during installation because it was originally positioned incorrectly. As a result, certain areas of the sealing element were compressed heavily or cut by the edges of the cylinder head.

- Use great care in preparing and carrying out the installation. If the cylinder head needs to be repositioned, the gasket must be inspected for damage.

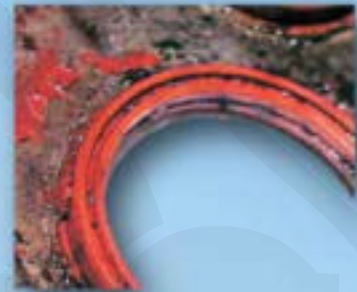
2. Cause of failure – oil leakage, sealing compound on sealing element (truck)

The elastomer sealing element has been pressed away from the carrier plate. Dirt particles are in the sealing groove.

Additional sealing compound was applied to the metal carrier plate. As a result of vulcanization, the elastomer sealing element was subjected to additional pressure and pushed back, causing oil leakage. The damage was accelerated by dirt particles that accumulated from the oil.

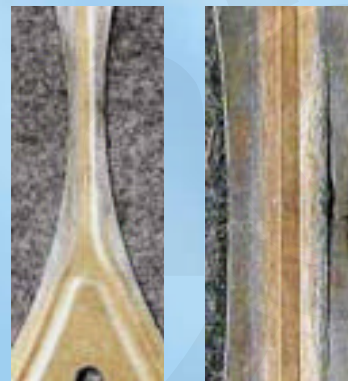
1. Cause of failure – uncontrolled combustion process on multi-layer metal gaskets

Initial black discoloration in the sealing web area of the functional layer indicates the start of destruction, which is complete in the second picture (right).

An uncontrolled combustion process generated high-frequency vibrations. The resulting shock waves destroyed the sealing web.

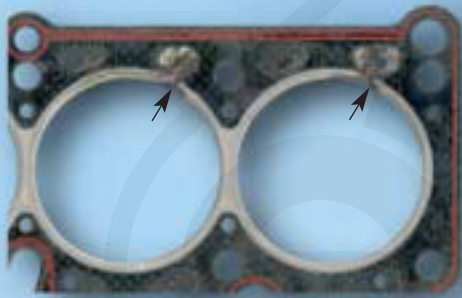
2. Failure of the cylinder-head gasket due to knock damage

Dents and deformations can be seen clearly on the metal combustion chamber eyelets. Melting of the eyelet and the soft material. The metal on the combustion chamber eyelet is usually bright in this area, and the soft material shows signs of scorching.

Engine not tuned (pre-ignition) as specified by the manufacturer, leading to uncontrolled combustion process. High-frequency vibrations and the resulting shock waves destroyed the metal sealing element of the combustion chamber and as a consequence, also the soft material.

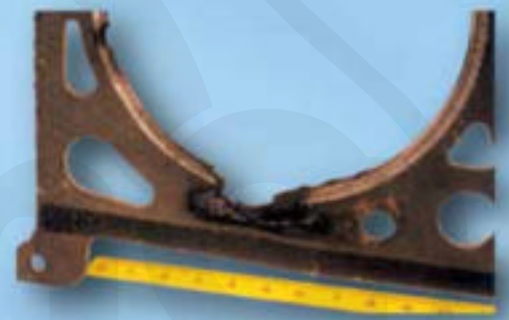
The combustion chamber eyelet is clearly dented. Damage of the combustion chamber eyelet ranging from initial signs to complete destruction of eyelet and the sealing material.

The use of fuel with insufficient anti-knock properties leads to an uncontrolled combustion process. This in turn results in thermal and mechanical overload on the engine. The uncontrolled combustion generates shock waves with extremely high pressure and temperatures, overstressing the engine components. Damage can be found most commonly on pistons and the cylinder-head gasket.

- Use anti-knock fuel.

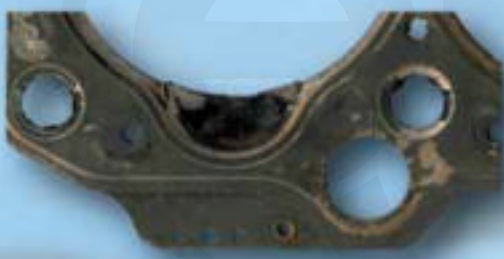
1. Failure of the cylinder-head gasket due to loose precombustion chamber

The multi-layer metal cylinder-head gasket has been damaged seriously by mechanical factors.

The whirl chamber for the first cylinder loosened during operation and fell into the combustion chamber. The result was serious damage to the cylinder head and pistons and in the valve gear.

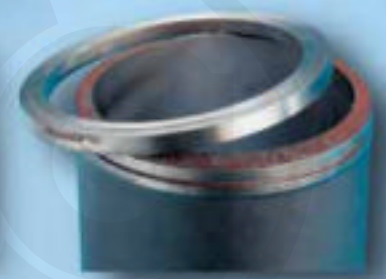
2. Failure of a cylinder-head gasket on a commercial vehicle due to improper installation

The metal combustion chamber eyelet of the cylinder-head gasket has been pressed entirely together on the inside by the collar of the liner. The extreme forces that arose when the engine was started blew off the collar of the liner, resulting in serious engine damage.

- Ensure that no force is required when placing the cylinder-head gasket on the liner.
