Engine damage: Failure caused by cylinder-head gasket? Actual causes and remedial measures

Cylinder-Head Gaskets

Engine failure caused by cylinder-head gasket?

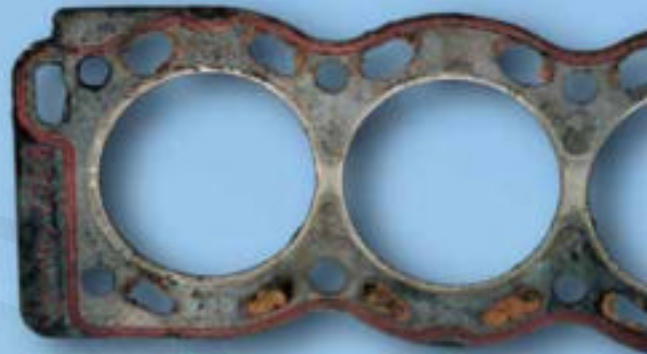
In the case of overheating of the cooling system, coolant penetrates into the soft material matrix of the gasket where it vaporizes due to the adjacent hot engine parts, pressing the soft material away from the metal carrier. The result is the waviness of the material.

One should not underestimate the consequences of using antifreeze and anti-corrosion agents that have not been approved or the use of pure water as coolant. The metal carrier plates of the gasket suffer massive decomposition as a result of corrosion, resulting in the destruction of the gasket.
